The NRC and Nuclear Power Plant Safety in 2010

A BRIGHTER SPOTLIGHT NEEDED

DAVID LOCHBAUM

Union of Concerned Scientists
March 2011

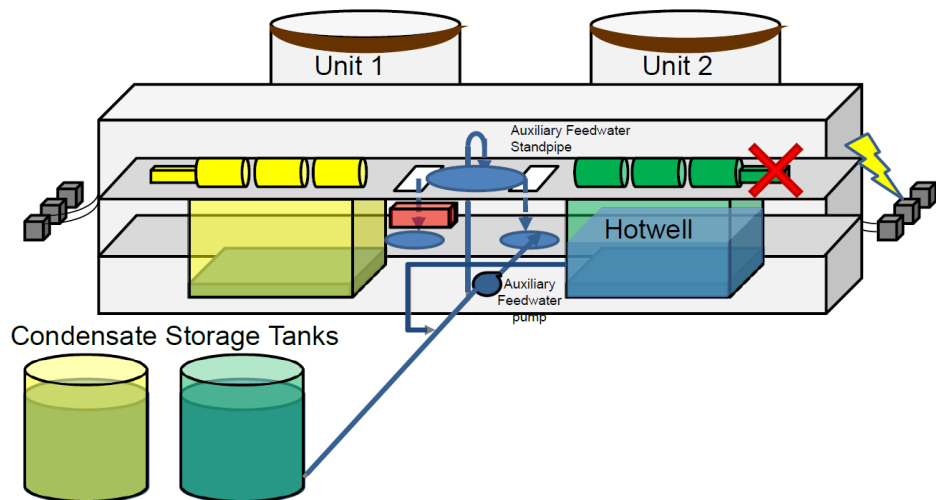
NRC drawing of the key components involved in the Braidwood near-miss. The red "X" indicates where the event started, when the main generator shut down.

However, the flow-control valve for one AFW pump failed in the open position, and the water level in the main condenser hotwell rose until valves opened to send some of this water back to the condensate tank. Nearly 12,000 gallons of water spilled onto the floor of the turbine building, from open standpipes installed on the piping between the outdoor tank and the AFW pumps (NRC 2010j).

Some of the spilled water flowed through holes in the floor and rained down on equipment on lower floors. Water leaked into an electrical panel housing controls for Unit 1 equipment. Two large pumps that circulate water between a nearby river and the main condenser stopped running because of electrical shorts. The reduction in cooling water flow through the main condenser impaired the condensation of steam inside the condenser. This impairment degraded the condenser's vacuum, triggering an automatic shut-down of the Unit 1 reactor about 15 minutes after the Unit 2 reactor shut down.

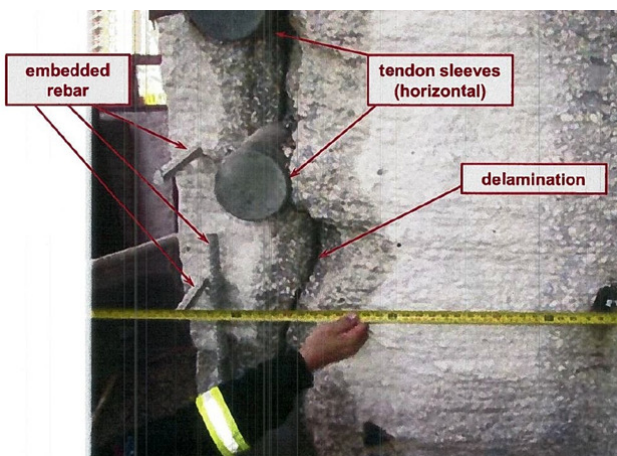
NRC picture of the crack (delamination) in the concrete containment wall at Crystal River 3 caused when workers cut a square opening to replace the steam generators.

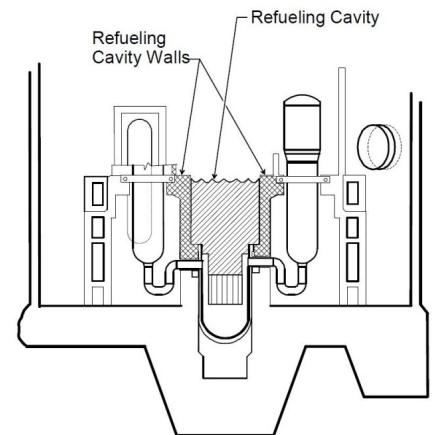
NRC drawing showing refueling cavity walls and the fuel rods located at the bottom of the cross-hatched refueling cavity volume.

However, NRC inspectors at Indian Point recently found that the liner has been leaking 2 to 20 gallons per minute since at least 1993 (NRC 2010v), and that the plant owner has not yet delivered on repeated promises to fix the leak. That means the device installed to prevent leakage after an earthquake is leaking before an earthquake even occurs. The liner has no other safety function. Yet NRC managers have dismissed the longstanding problem, noting that the refueling cavity leaks only when it is filled with water (NRC 2010o).

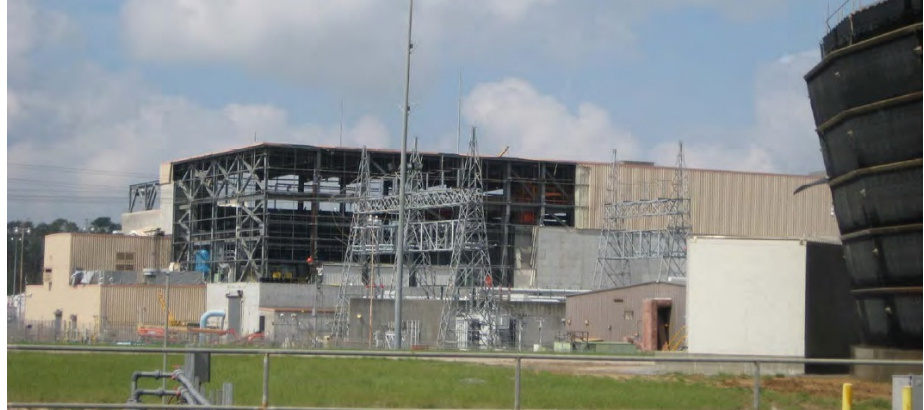
In September 2008, Hurricane Gustav caused considerable damage to the River Bend nuclear plant outside Baton Rouge, La. High winds tore sheet metal siding from three sides of the turbine building. The company repaired some damage and prepared to restart the reactor—planning to replace the walls of the turbine building later.

The turbine building at the River Bend plant after Hurricane Gustav removed its metal siding. NRC photo.
